1.0 INTRODUCTION

[Big] Silver Lake, Waushara County, is a seepage lake with a maximum depth of 48 feet and a mean depth of 21 feet. The lake area as determined through a heads-up digitization of the lake from a 2015 aerial photograph is approximately 360.3 acres, whereas the WDNR website lists the lake as 328 acres. This mesotrophic lake has a relatively small watershed when compared to the size of the lake (3.5:1). When water levels are near full pool, water exchange occurs with Irogami Lake via a culvert under State Hwy 21 (Figure 1.0-1). Four exotic species are known to exist in Silver Lake: banded mystery snail, curly-leaf pondweed (*Potamogeton crispus*, CLP), Eurasian water milfoil (*Myriophyllum spicatum*, EWM), and zebra mussel. Genetic analysis confirms that the invasive milfoil population is comprised of both EWM and hybrid water milfoil (*M. spicatum x sibiricum*, HWM). Subsequent discussion using “HWM” will represent the collective invasive milfoil population of Silver Lake unless specifically referenced otherwise.

Silver Lake

Waushara County, Wisconsin

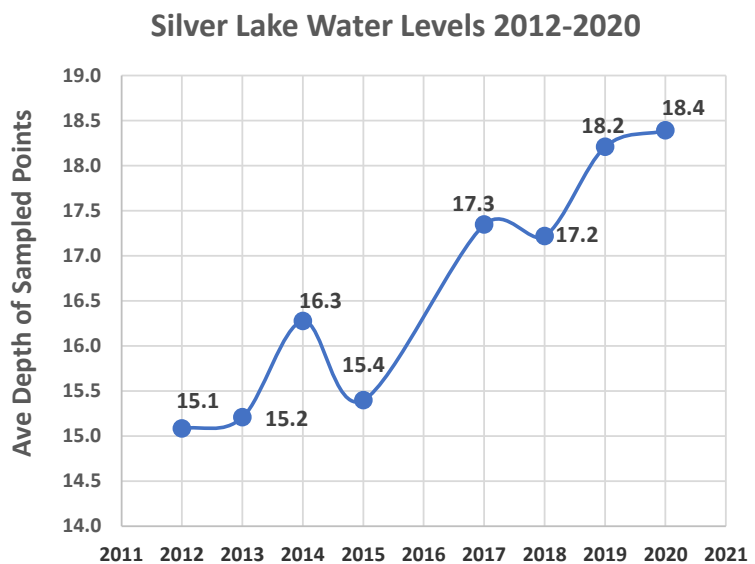
Figure 1.0-2. Water levels in Silver Lake from 2012-2020 based on data collected from annual point-intercept surveys.

Water levels in 2019 were at some of the highest levels ever recorded in the lake and resulted in the enforcement of a slow-no-wake ordinance to limit shoreland erosion that could be exacerbated by waves created by boaters. Data from recent point-intercept surveys indicate that the water levels in Silver Lake increased by approximately two feet between 2015 and 2017, and increased another foot between 2018 and 2019 (Figure 1.0-2). Water levels remained at a high level for the duration of the 2020 growing season with the point-intercept data showing a slight increase in average depth of sampled points compared to 2019.

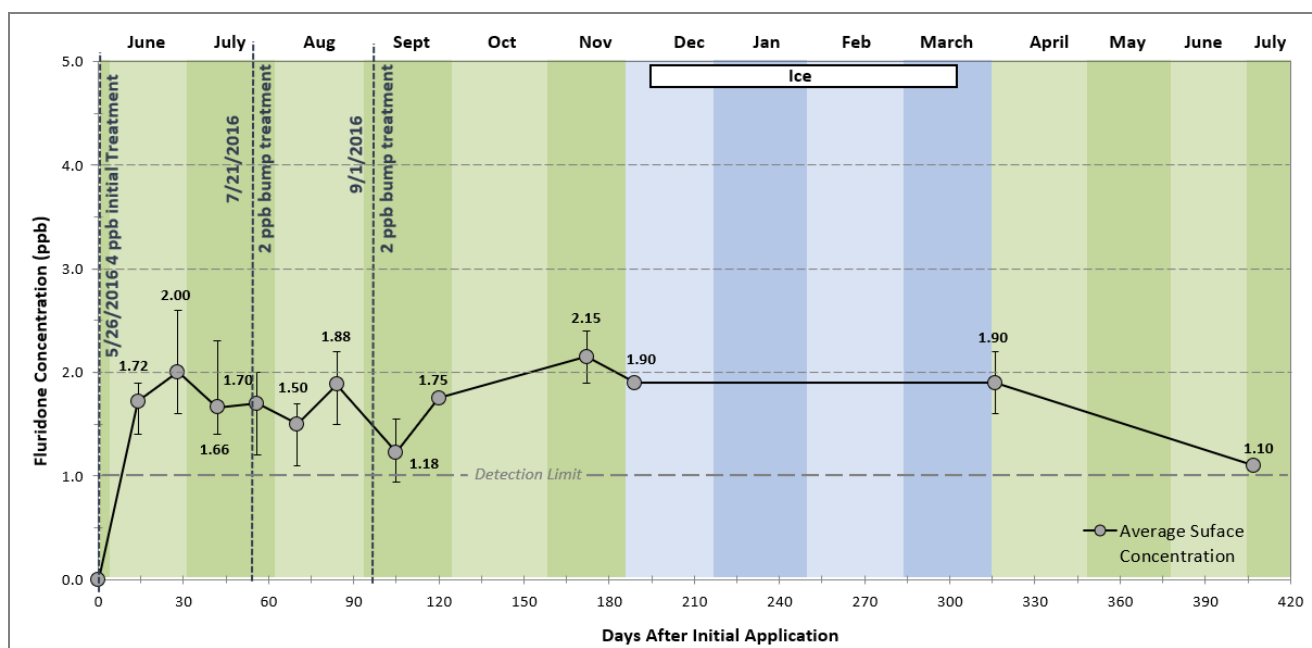
Figure 1.1-1. Fluridone concentrations measured in Silver Lake in association with a 2016 whole-lake treatment.

The 2016 treatment included application of pelletized fluridone over 86.4 acres of the littoral zone. The initial herbicide treatment was conducted on May 26, 2016. Based upon reviewing the measured herbicide concentration during the summer as well as technical advice from SePRO, 2 ppb bump treatments of pelletized fluridone (Sonar One®) were conducted on July 21 and September 1. The final dosing of these treatments was based on a mixing zone down to 21 feet and includes application of pelletized fluridone over the same 86.4 acres where the initial application occurred. The measured fluridone concentrations in the time period during and after the treatments are displayed on Figure 1.1-1. Note that fluridone concentrations persisted at a consistent level during the winter months and were detectable as late as July 2017. More specific details related to the 2016 fluridone treatment have been reported on in recent annual reports as a part of this project.

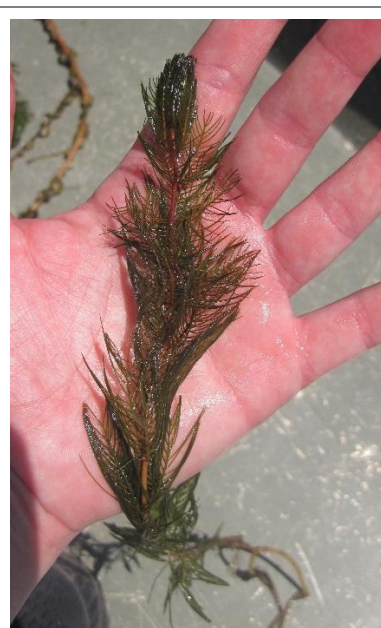
Photo 1.5-1. HWM observed during a June 2, 2020 pre-treatment survey on Silver Lake. Photo by Onterra, LLC

During the survey, surface water temperatures were measured at 70°F in the treatment area and 67°F at mid-depth. Actively growing HWM was confirmed within the proposed treatment site characterized by green growth (Photo 1.5-1). Native aquatic plant growth in the treatment area was mainly comprised of pondweed species and coontail. An underwater camera transect was completed through the targeted area which can be viewed on Onterra's YouTube webpage ([Click Here](#)). Based upon the survey, no modifications were made to the treatment strategy. The field crew also delivered the herbicide concentration monitoring supplies to a volunteer from the SLMD during the visit. Map 2 reflects the final treatment strategy using ProcettaCOR™ with an application rate of 3.5 PDU's over one site totaling 11.6 acres.

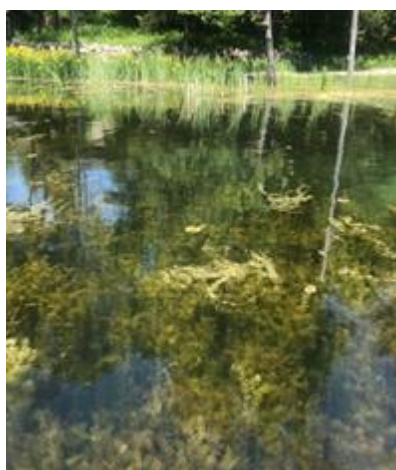
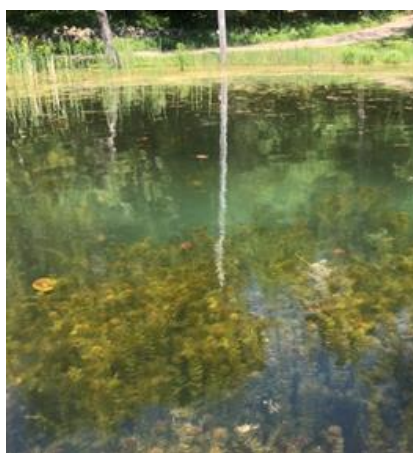
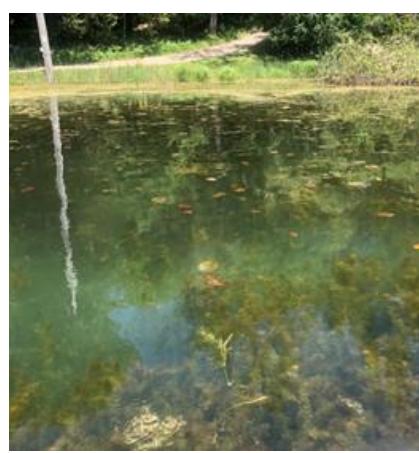
Photos 1.5-2. HWM growth observed during a pre-treatment site visit on Silver Lake. Photos by Clarke Aquatic Services, Inc.

Significant growth of HWM within Foxtail Bay was also documented during a pre-treatment site visit conducted by the applicator on June 7, 2020 (Photos 1.5-2). The herbicide application was completed on June 8, 2020 by Clarke Aquatic Services, formerly Clean Lakes, Inc.

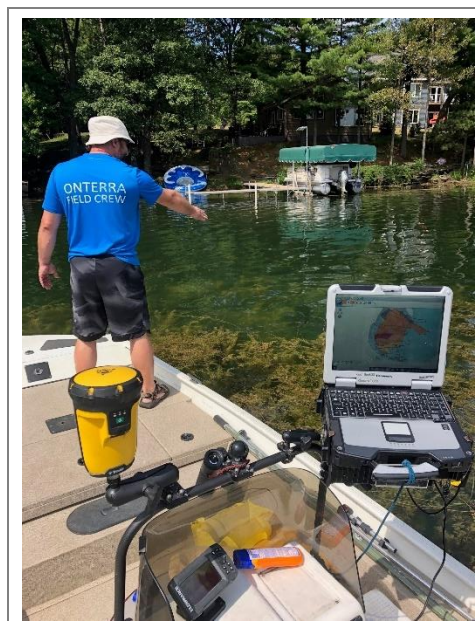
Photograph 2.0-1. EWM mapping survey on a Waushara County, WI lake. Photo credit Onterra.

While the point-intercept survey is a valuable tool to understand the overall plant population of a lake, it does not offer a full account (census) of where a particular species exists in the lake. During the HWM mapping survey, the entire littoral area of the lake is surveyed through visual observations from the boat (Photograph 2.0-1). Field crews supplement the visual survey by deploying a submersible camera along with periodically doing rake tows. The HWM population is mapped using sub-meter GPS technology by using either 1) point-based or 2) area-based methodologies. Large colonies >40 feet in diameter are mapped using polygons (areas) and are qualitatively attributed a density rating based upon a five-tiered scale from *highly scattered* to *surface matting*. Point-based techniques were applied to AIS locations that were considered as *small plant colonies* (<40 feet in diameter), *clumps of plants*, or *single or few plants*.

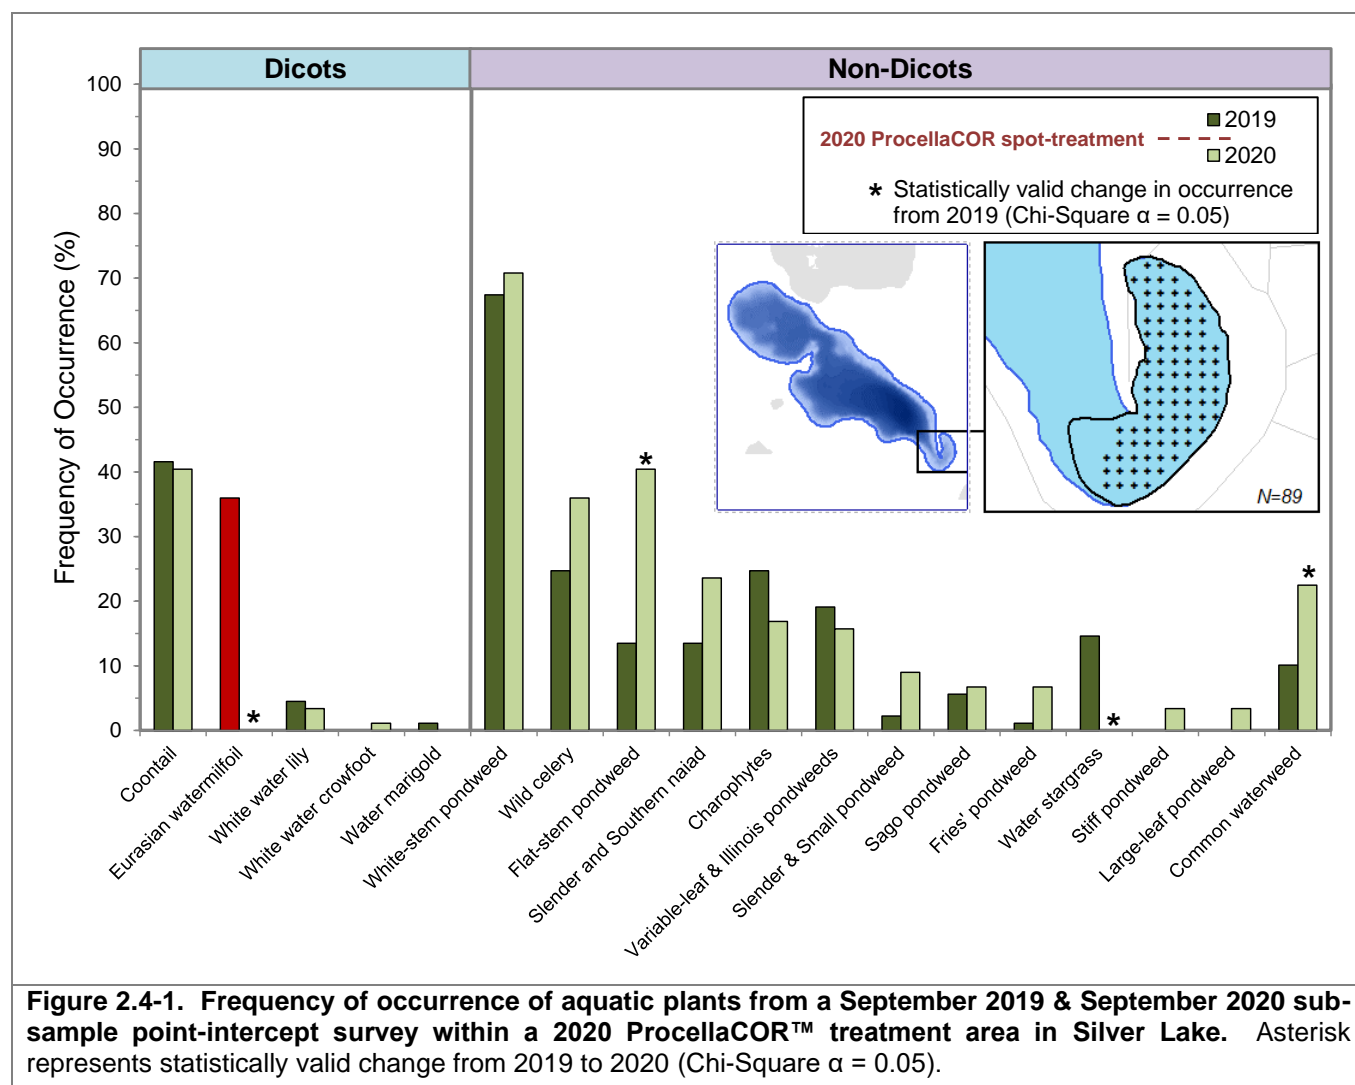
Figure 2.4-1 displays the results of the sub-sample point-intercept surveys from before and after the herbicide treatment. HWM was not found at any of the 89 sampling locations during the post-treatment survey compared to a 36% occurrence in the pretreatment survey. The native species response to the treatment is also displayed on Figure 2.4-1. One species, water stargrass (*Heteranthera dubia*), exhibited a 100% decrease in occurrence between the two surveys. Flat-stem pondweed (*Potamogeton zosteriformis*) and common waterweed (*Elodea canadensis*) exhibited statistically valid increases in occurrence between the two surveys. Most native species did not show a statistically valid change in occurrence between the two surveys.

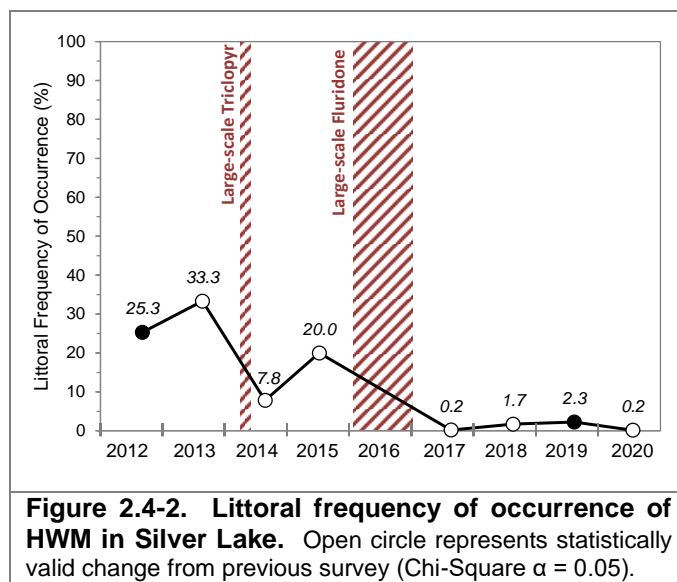
Figure 2.4-2 displays the littoral frequency of occurrence of HWM in Silver Lake from 2012-2020. Following the 2016 fluridone treatment, the data show that the littoral frequency of HWM was initially as low as 0.2% in 2017 and increased incrementally with a 1.7% occurrence in 2018 and 2.3% occurrence in 2019. During the 2020 survey, HWM exhibited an occurrence of 0.2%, which represents a statistically valid decrease in occurrence compared to the previous survey. The HWM population has been maintained at a relatively low level during the course of the last four years as the SLMD enacted an integrated pest management strategy following the 2016 whole-lake fluridone treatment.

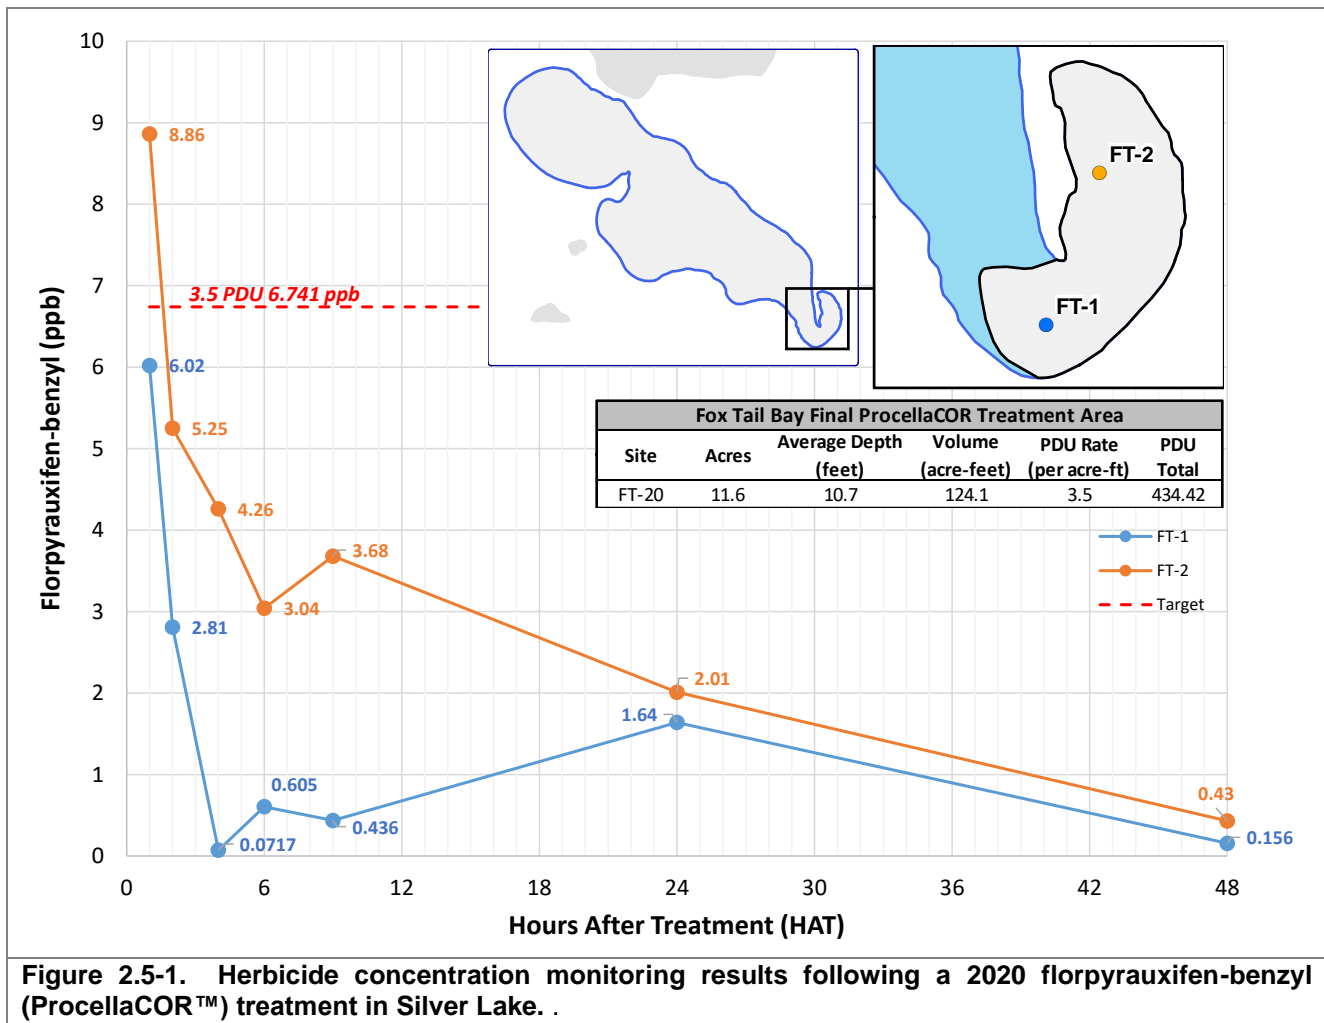
Figure 2.5-1 displays the results of the post treatment herbicide concentration monitoring. The application rate is converted to parts per billion of florpyrauxifen-benzyl and is displayed as dashed red line on the graph. The first samples collected after treatment at 1 HAT (Hour After Treatment) showed concentrations near or slightly above the application rate at the monitoring sites. Samples collected from site FT-2 were consistently higher than from site FT-1, likely due to the more protected location within Foxtail Bay. By the time of the last sample collection at 48 HAT, the herbicide concentrations at each monitoring location were below 0.5 ppb.

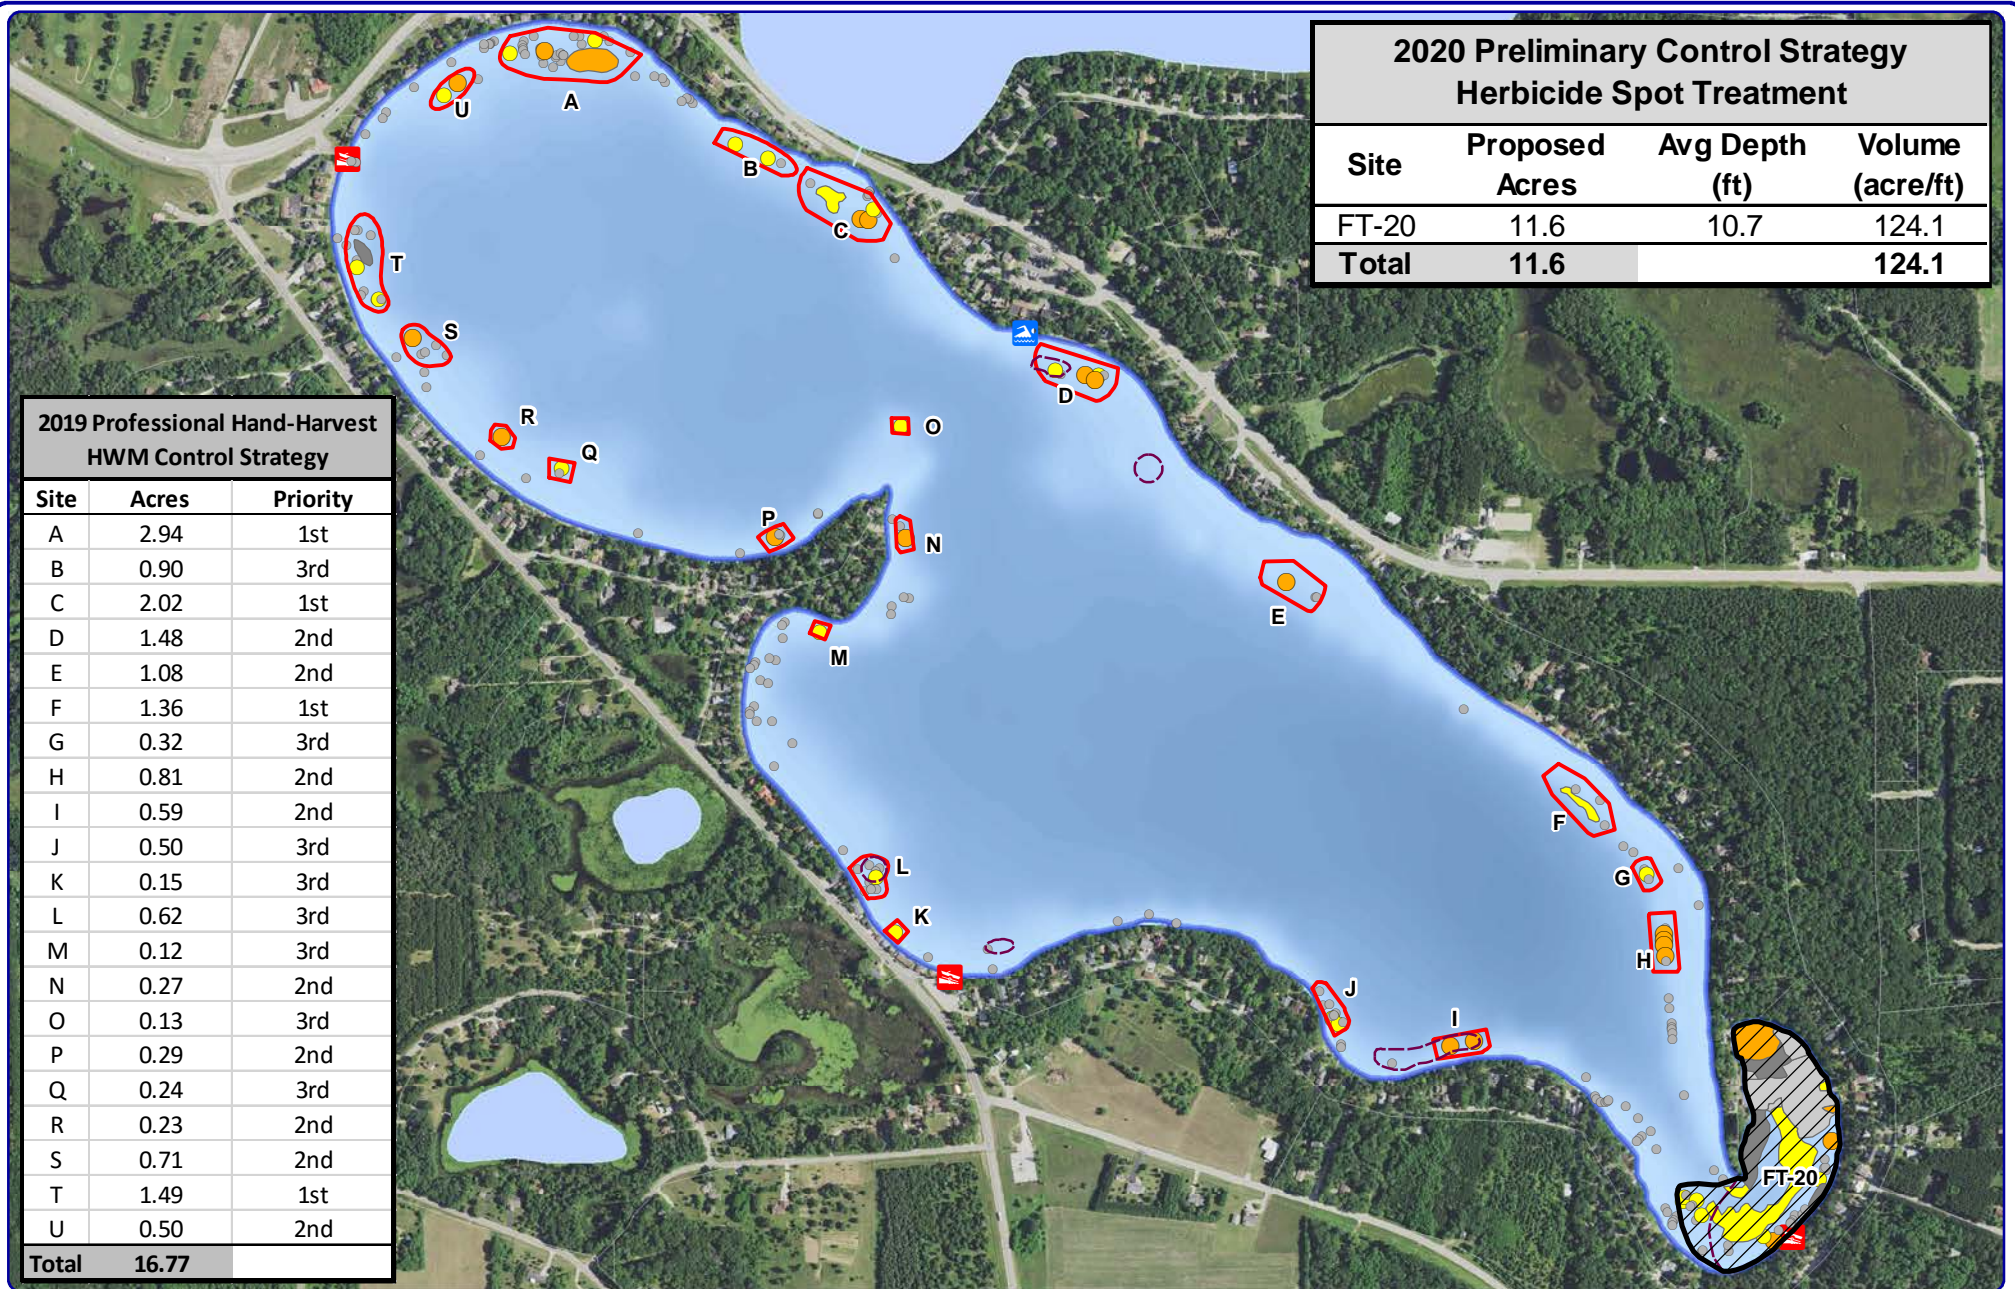
Map 1

**Proposed 2020 HWM
Management Strategy**

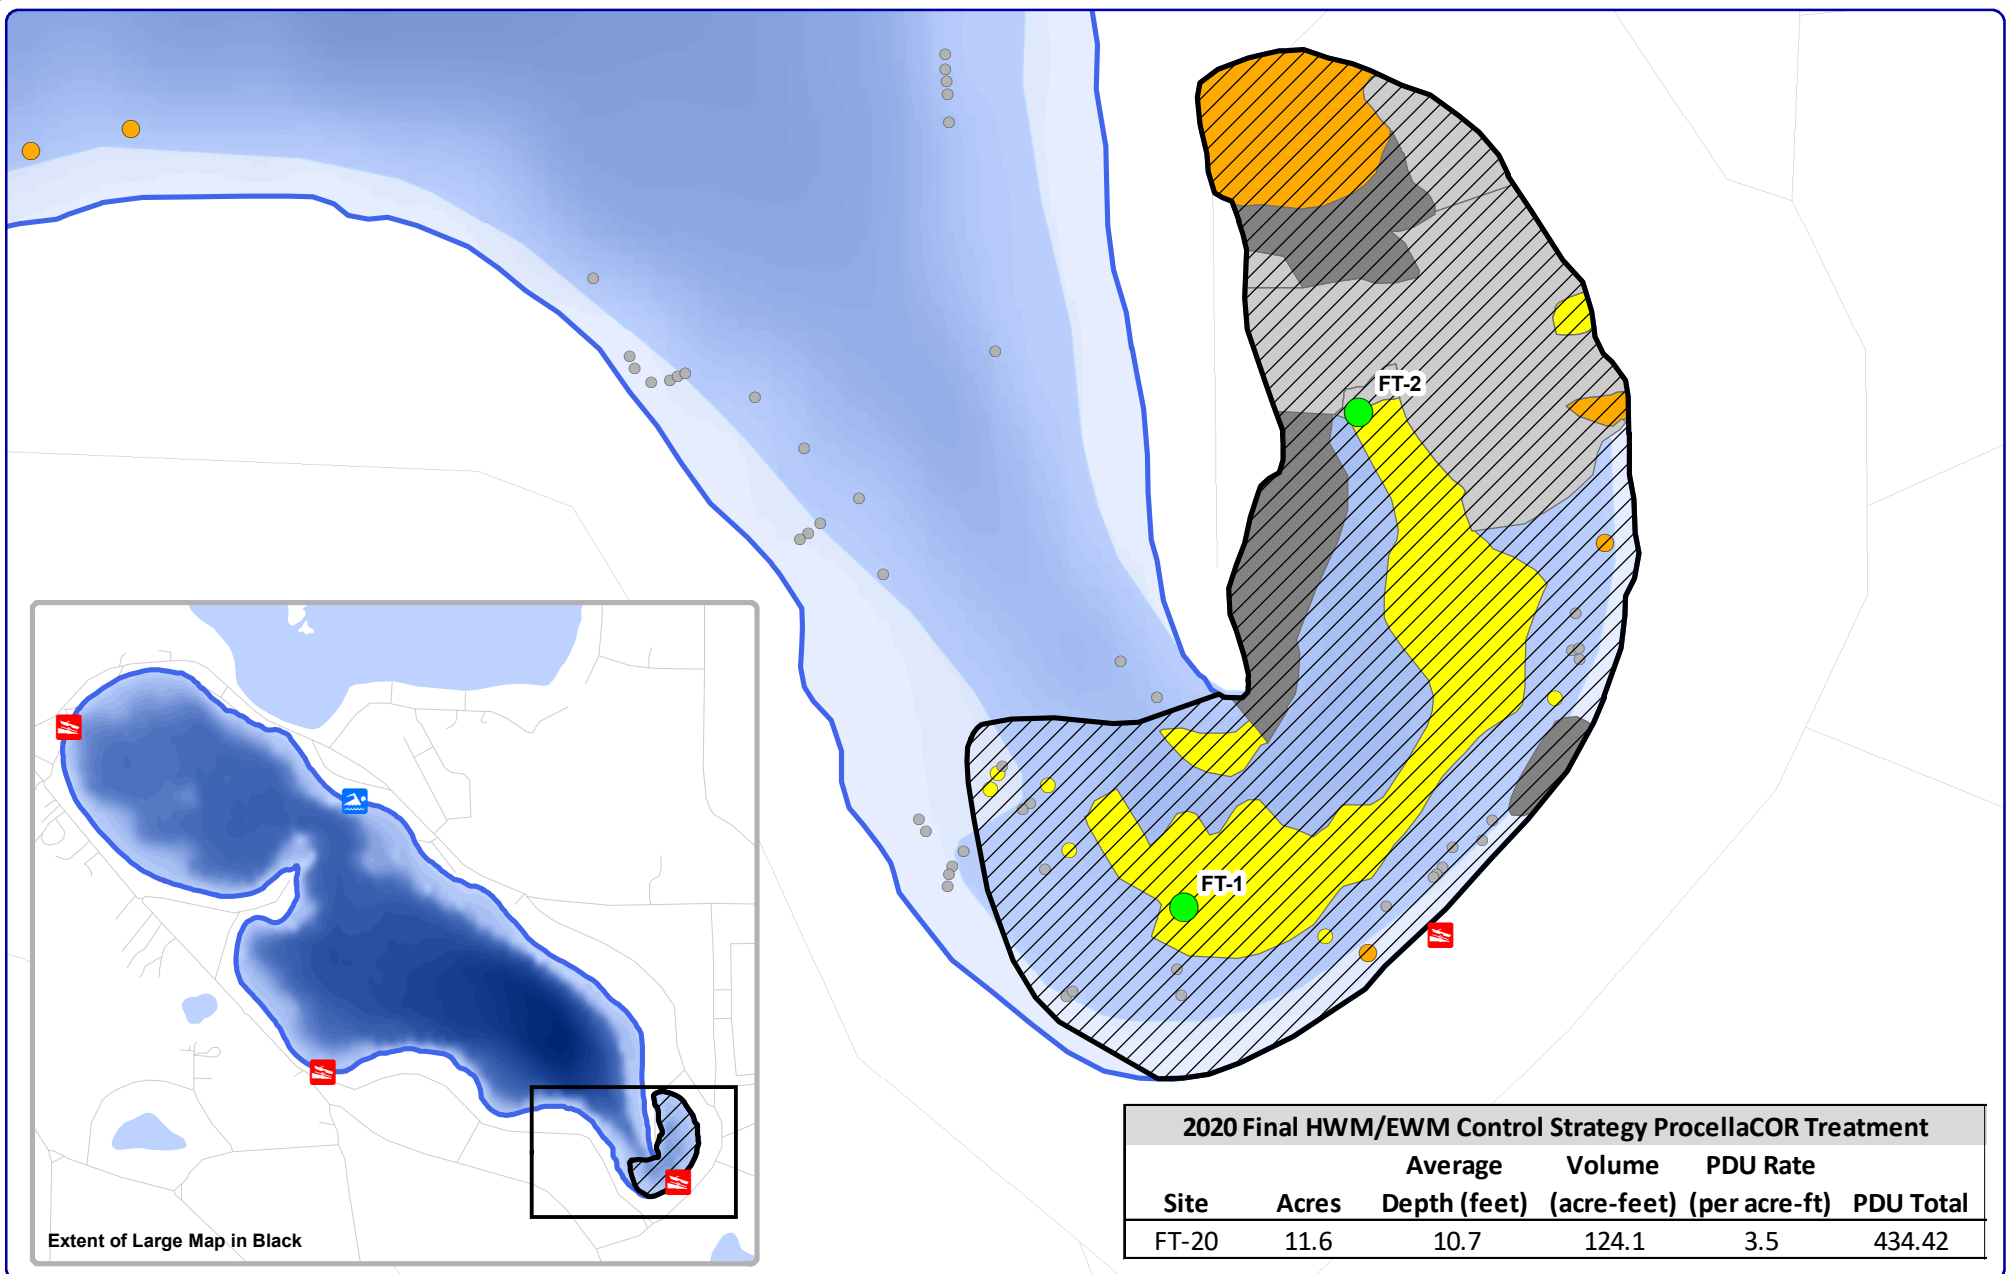
Map 2
 Silver Lake
 Waushara County, Wisconsin
Final 2020 HWM/EWM Control Strategy

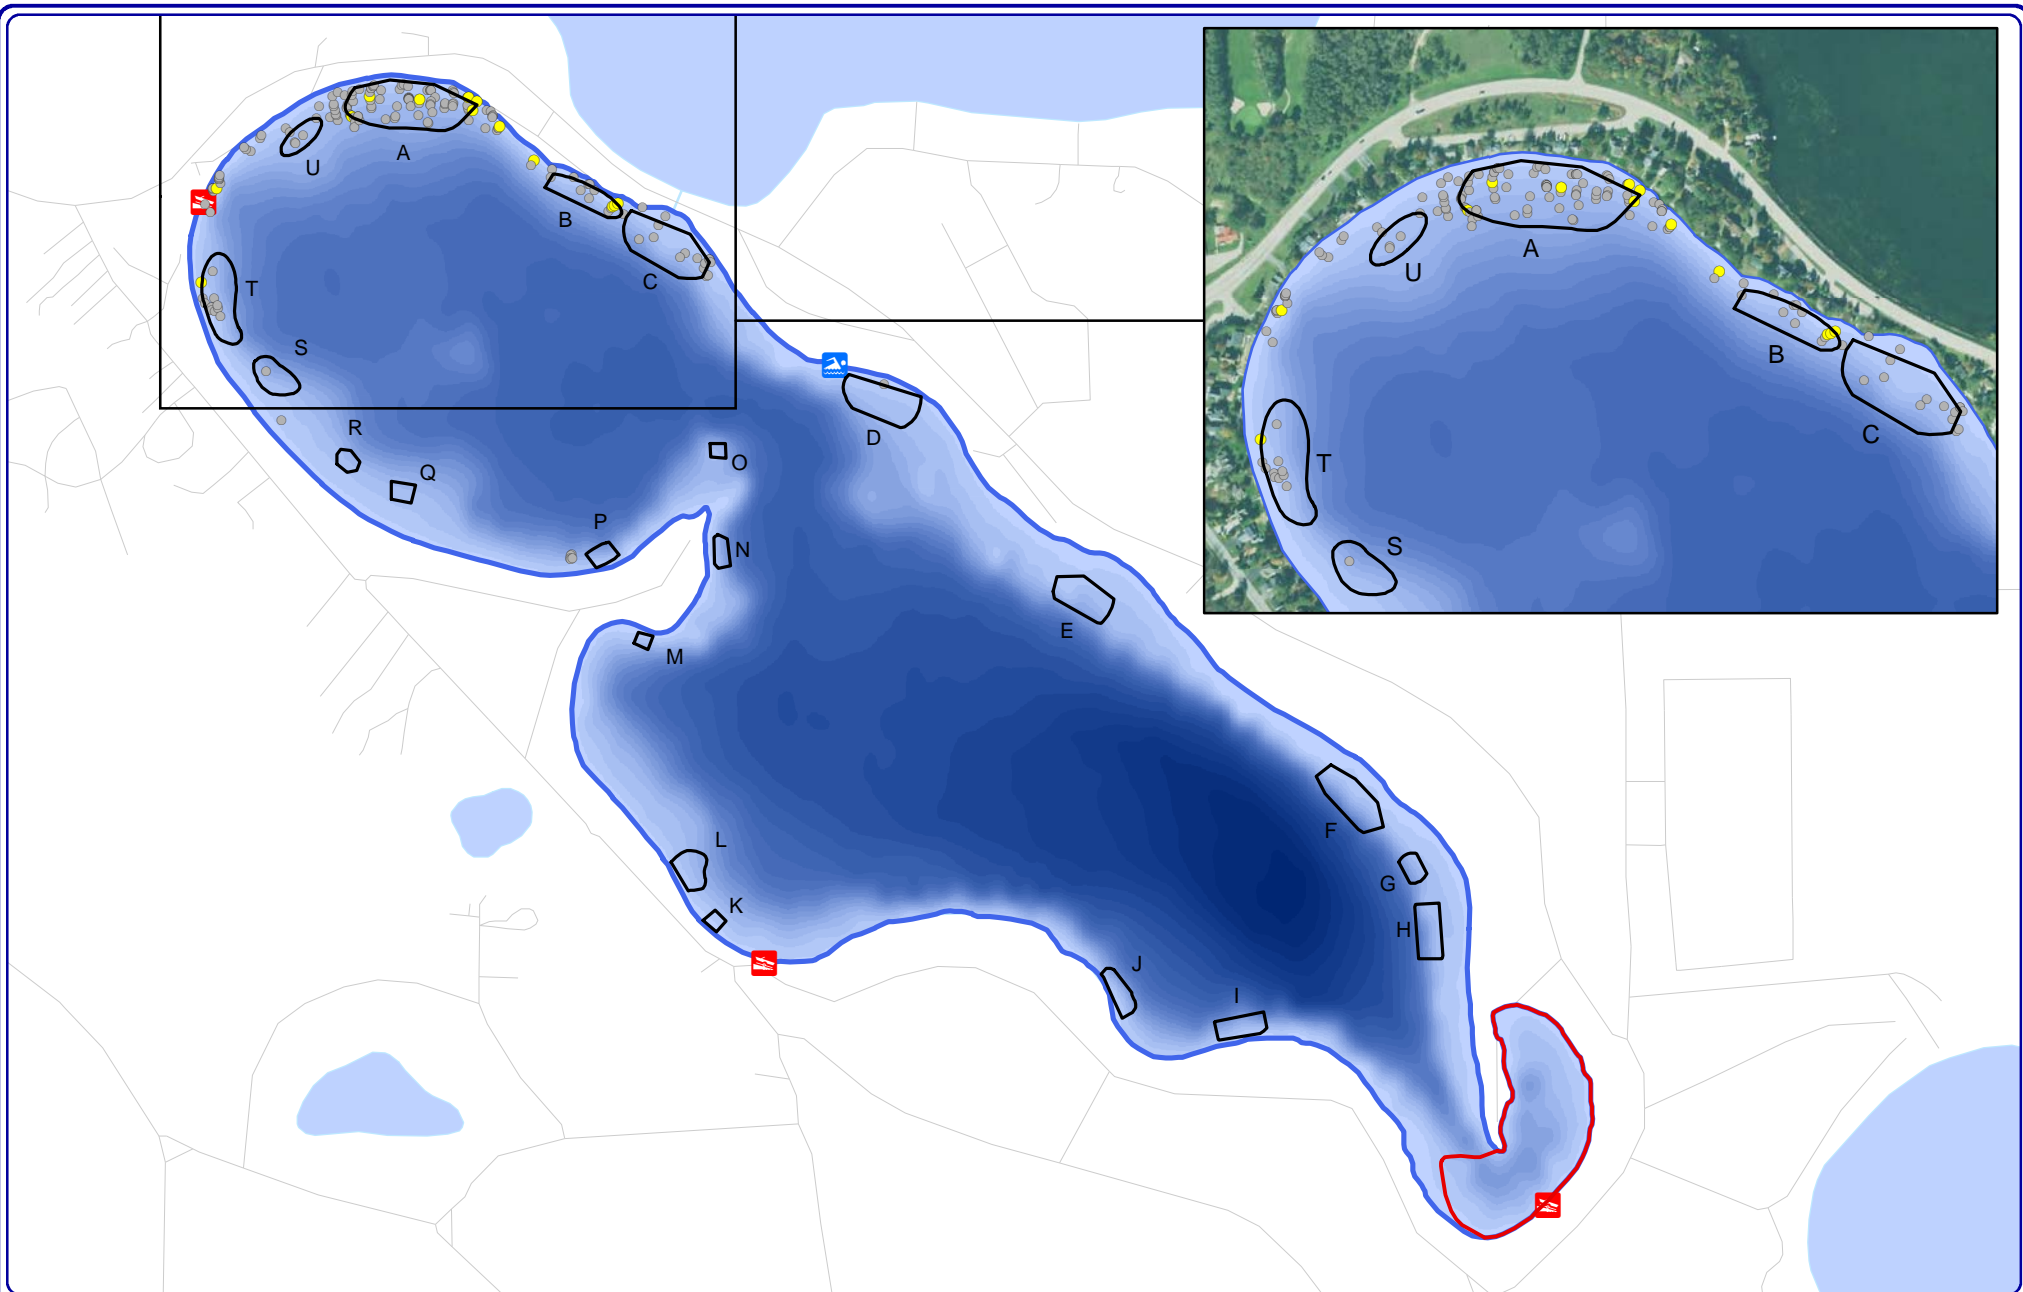
Map 3

**July 2020 EWM
Survey Results**

The results of the mapping survey are displayed on Map 3. Crews located less HWM than expected in the lake with no colonized areas detected anywhere in the lake. All occurrences that were located consisted of individual plants, or small clumps of plants. Essentially all of the singles and clumps of HWM were in the northern half of the lake. The largest concentration of singles and clumps were in the northwest end of the lake as displayed on the inset view of Map 3. No HWM was located in the southern half of the lake, including a survey of Foxtail Bay, where no HWM was located in optimal survey conditions with exceptionally clear water and protection from any wind at the time.

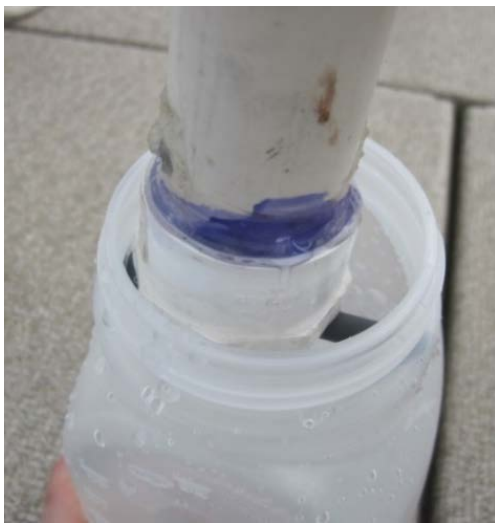
Photo 2. Emptying the water sample from the integrated sampler device into the custom mixing bottle.

It is important to rinse the integrated sampler and the custom mixing bottle with the water from each sampling site upon arrival at the site. Water is collected by pushing the integrated sampler straight down to a depth of six feet; or in water shallower than six feet, down to approximately one foot above the bottom sediment. The sampler is brought to the surface and emptied into a customized mixing bottle by pushing open the stop valve at the end of the integrated sampler (Photo 2). Water from the custom mixing bottle should be used to triple rinse the clear glass bottle. After the clear glass bottle is triple rinsed, it is to be filled for a fourth time with the water from the custom mixing bottle and then carefully poured into the brown glass bottle which has a preservative solution already inside (Photo 3). The sticker on the brown glass bottle must be appropriately labeled with the site label and time interval for which the sample was collected (Example: FT-1, 1 HAT). The final sample (in the brown bottle) as well as the emptied clear glass bottle should be carefully placed within the provided bubble wrapped pouch to protect from accidental breakage.

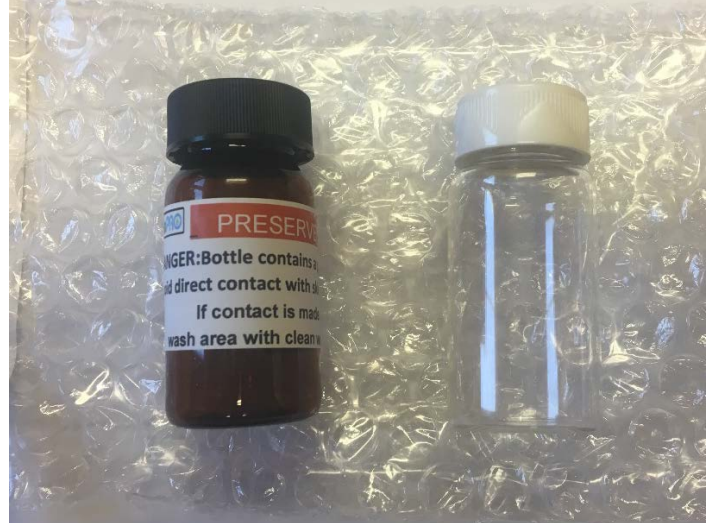
Photo 3. Clear glass mixing bottle (right) and final brown glass bottle (left).
